BUREAU OF SHIPS
TECHNICAL INSPECTION REPORT.

OPERATION CROSSROADS.
U.S.S. FALLON (APA 81).

TEST BAKER.

VOLUME 2 [U].

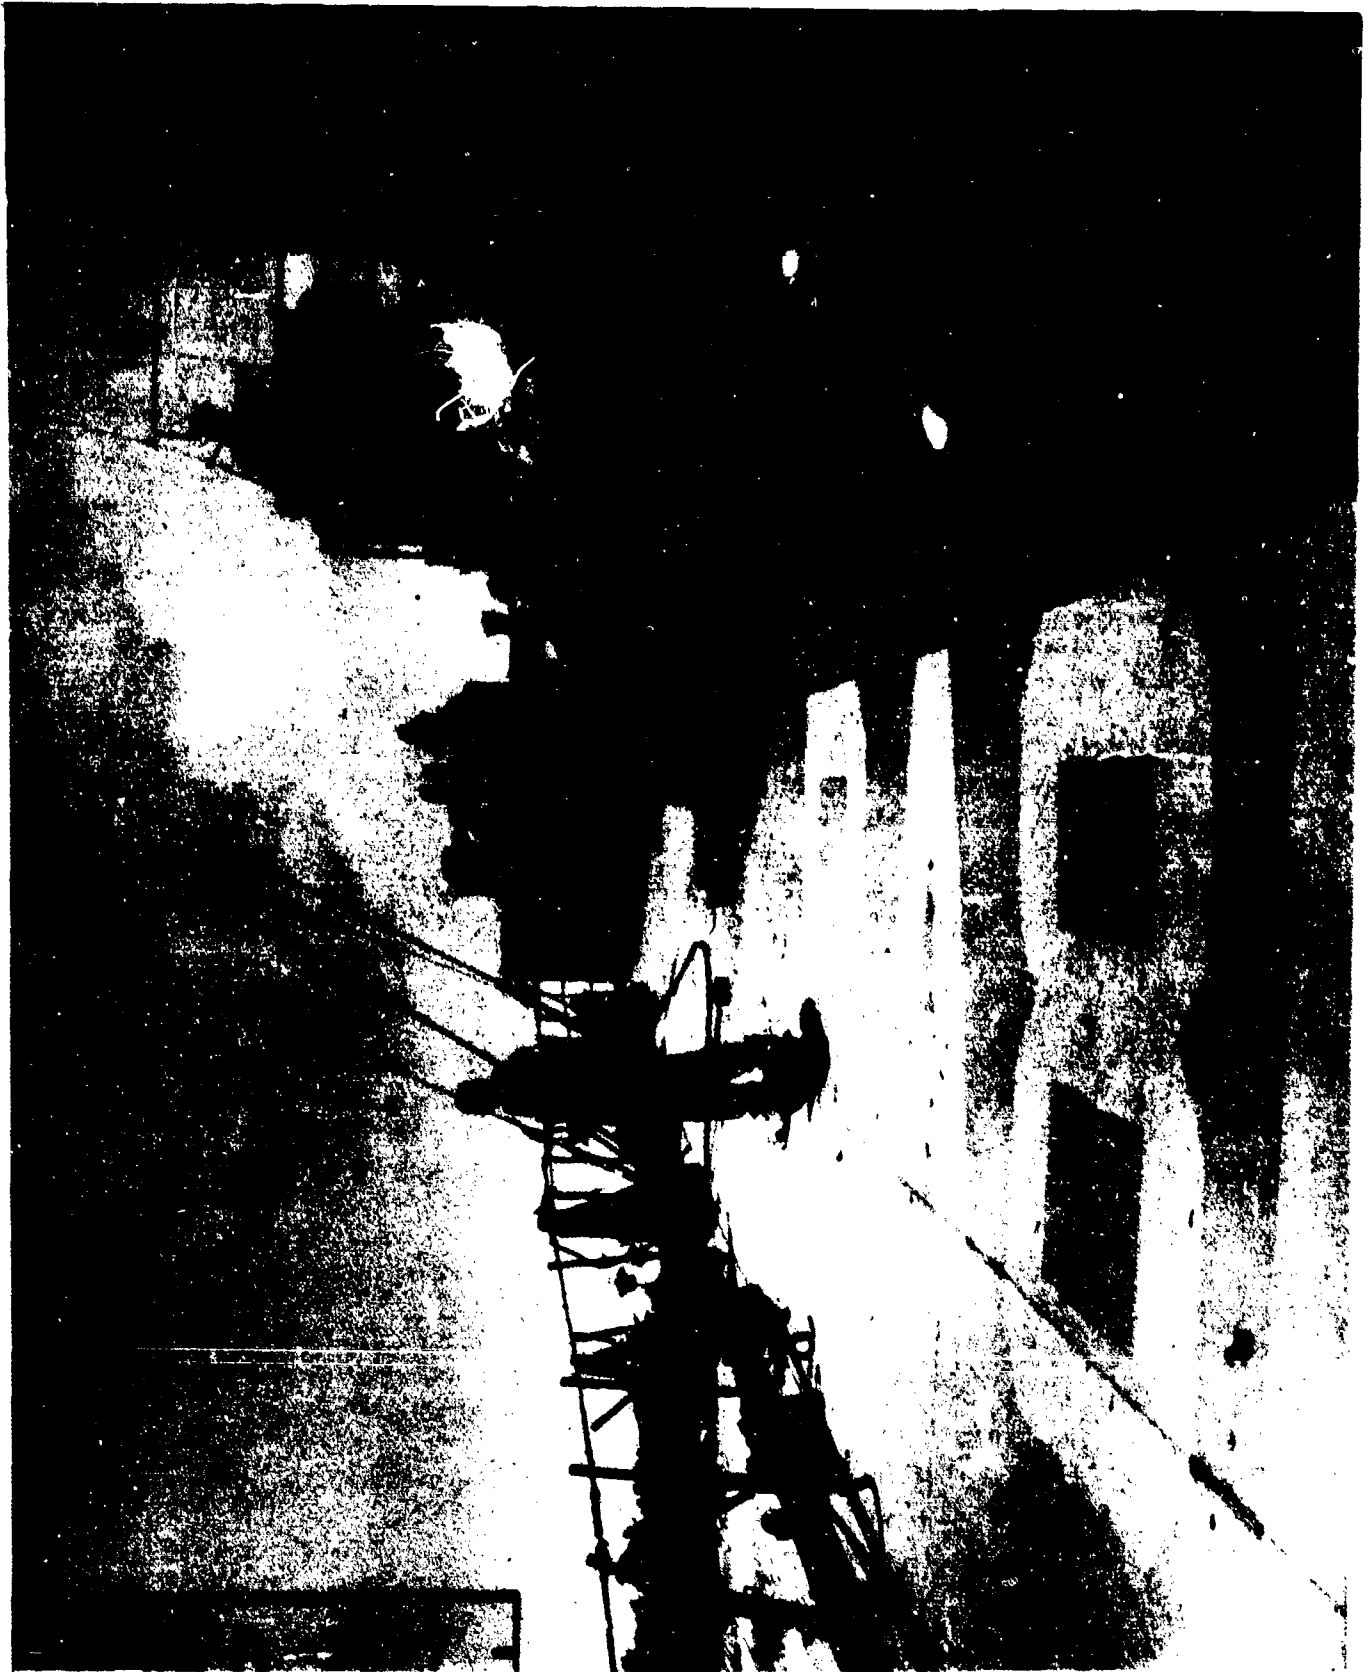
AB-CR-80-2197-4. Looking forward on upper deck along port side of No. 1 cargo hatch showing deck dishing, displaced winch, and cargo boom lying to starboard.

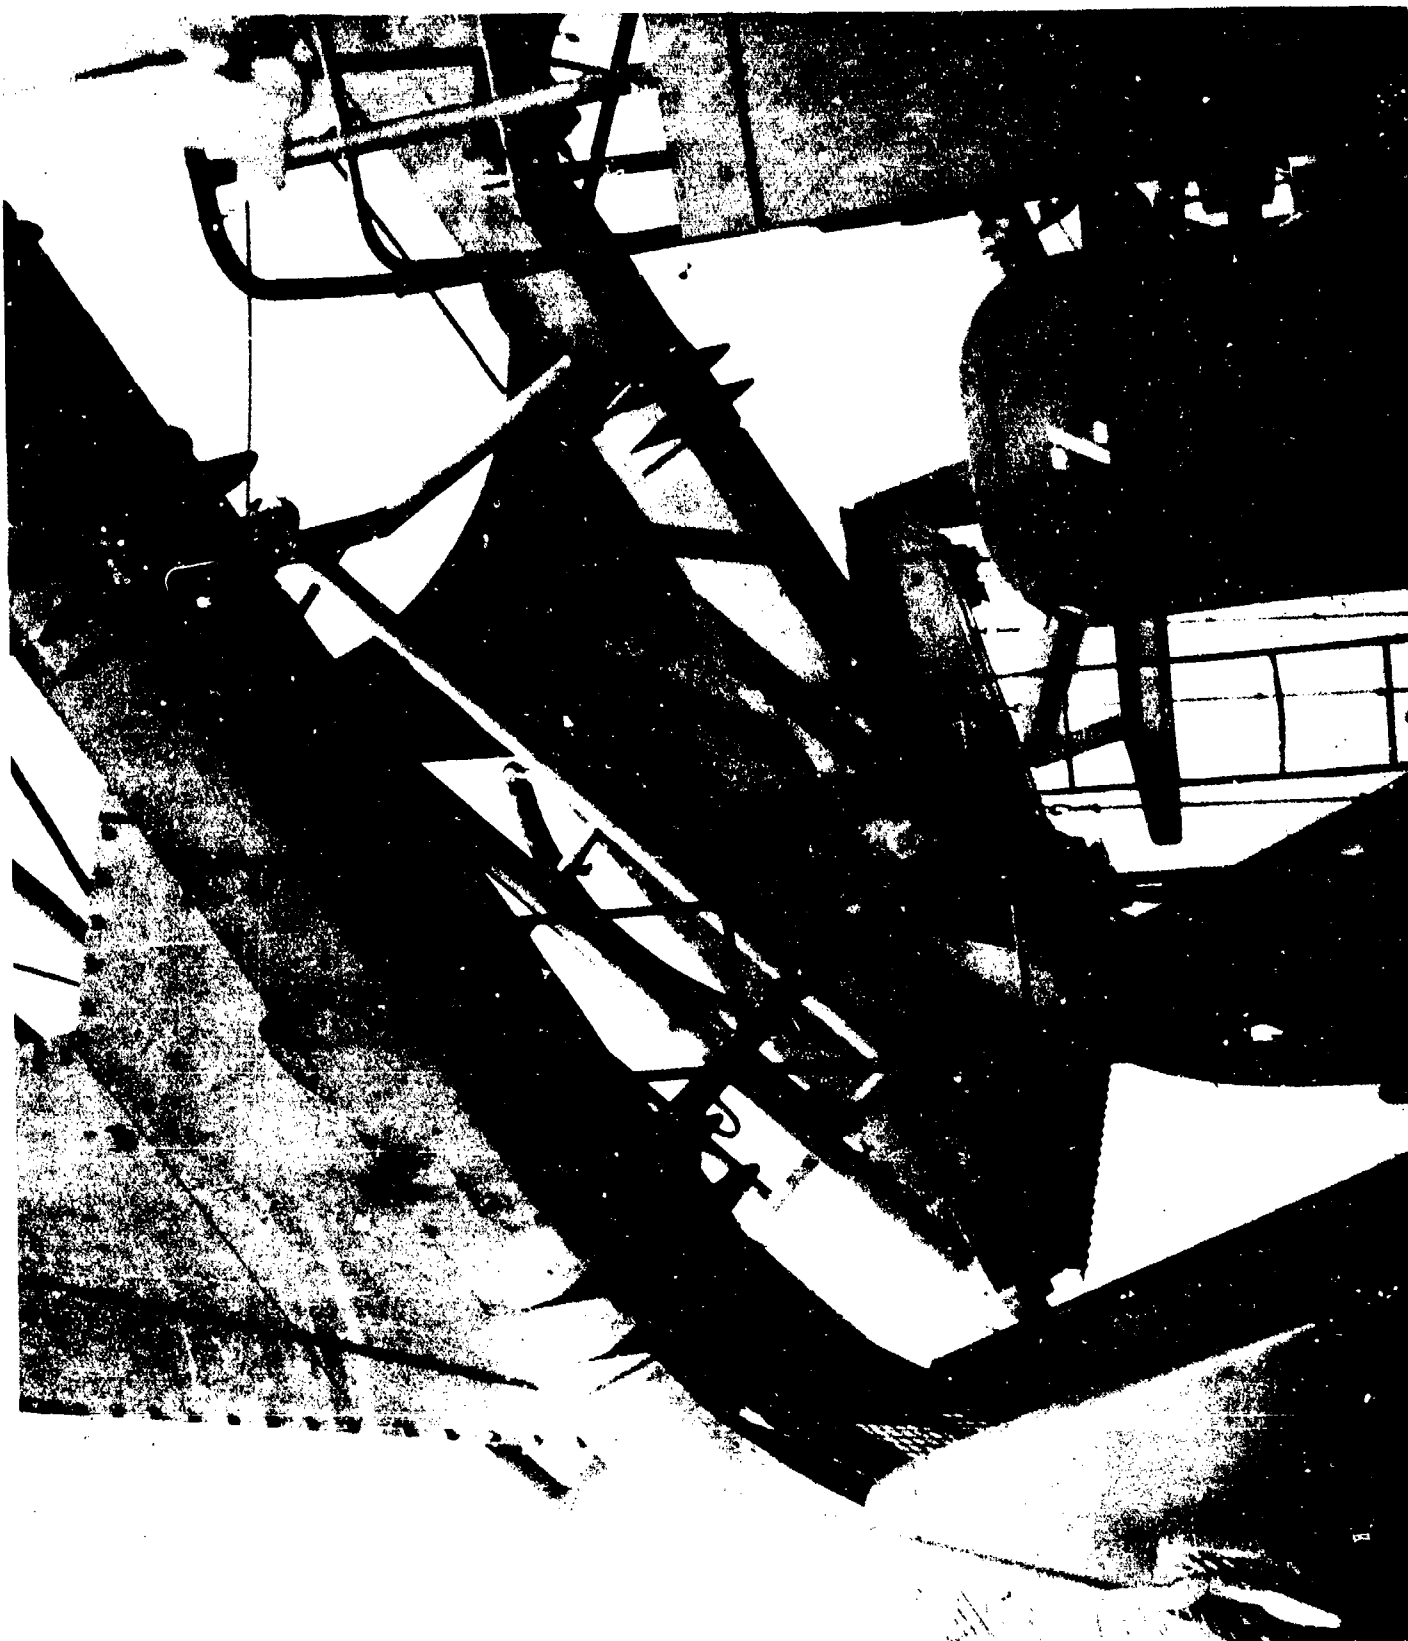
AB-CR-66-159-9. Welin davit track buckling, upper deck starboard, frame 84, looking aft.

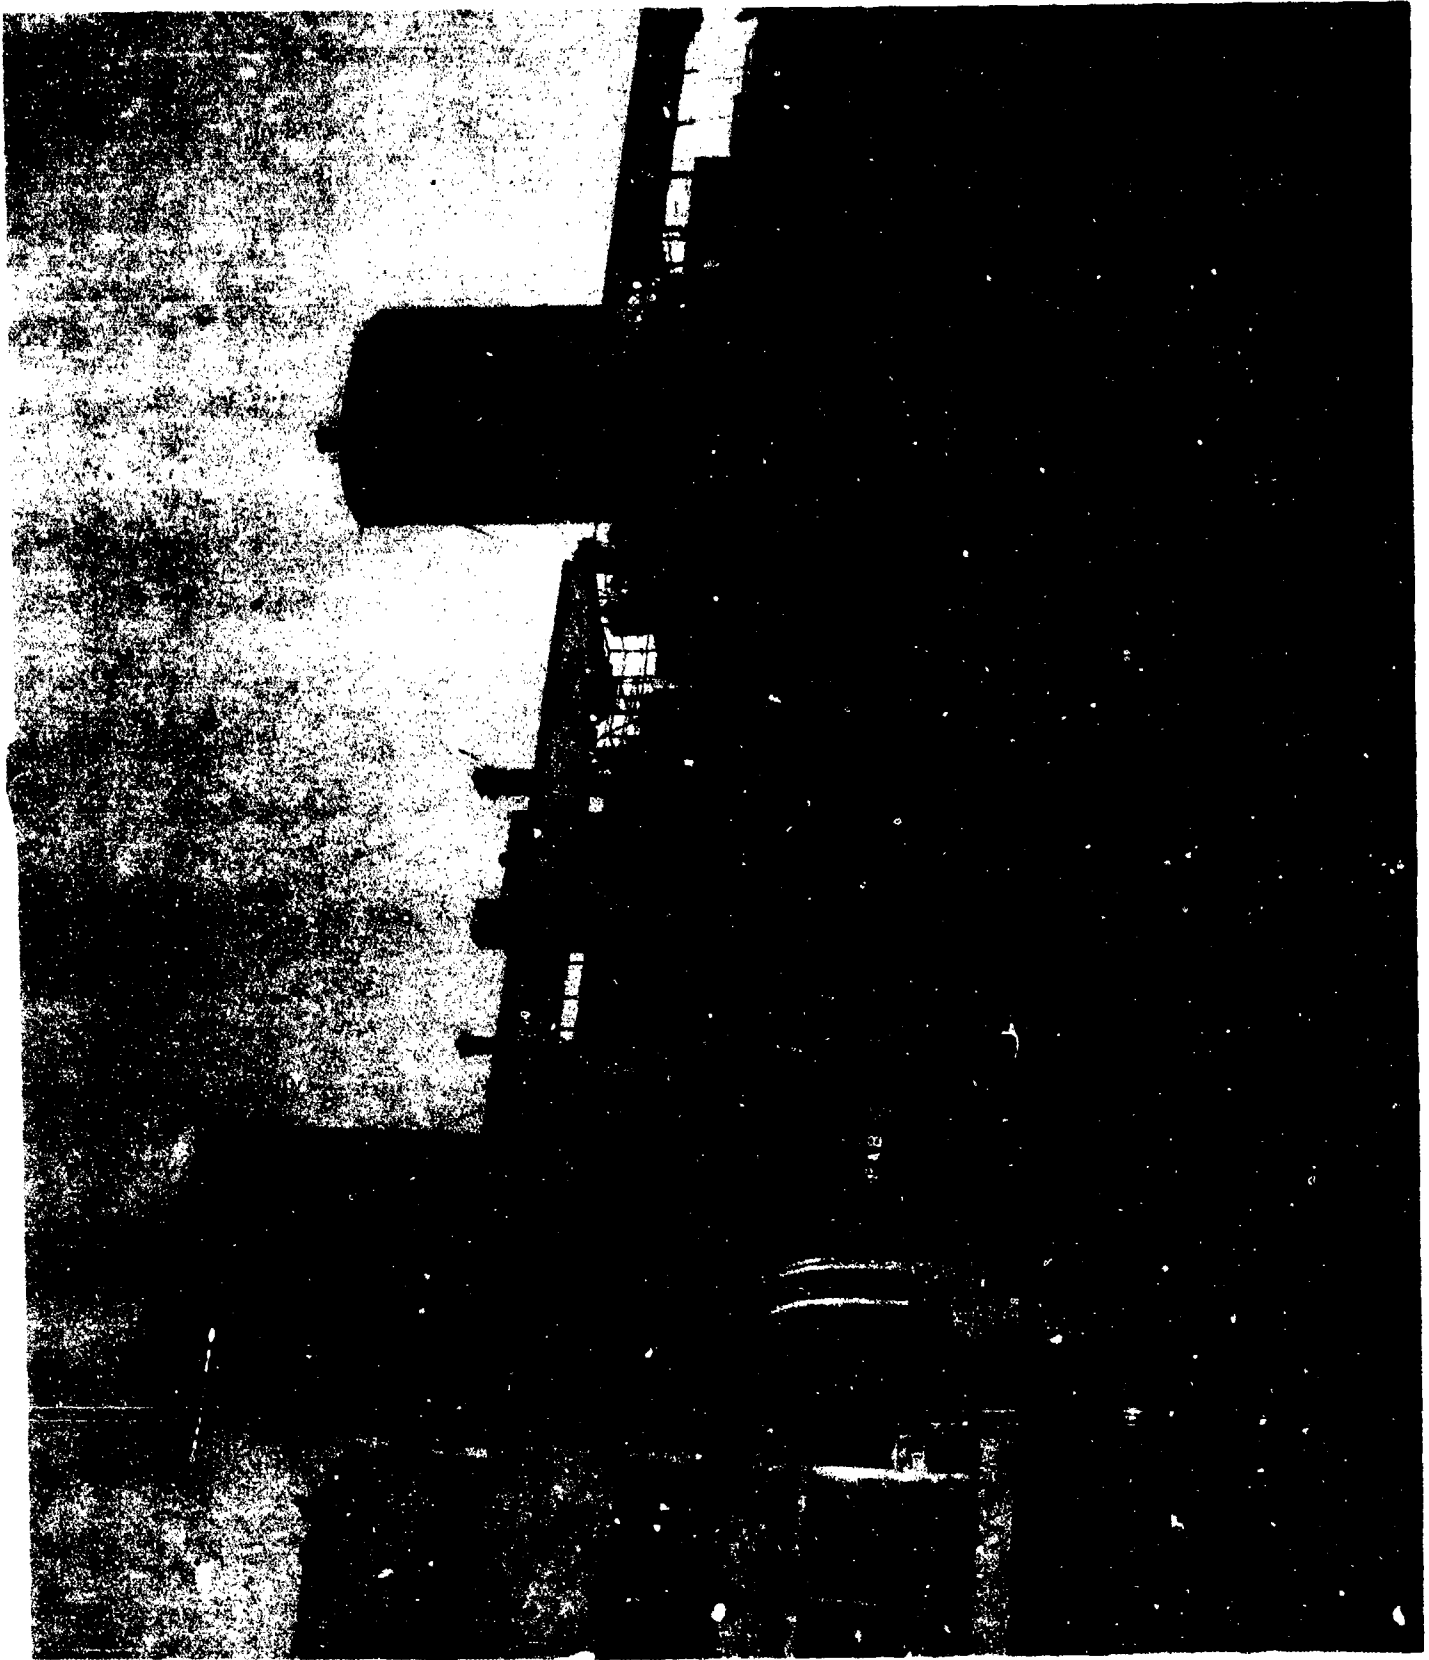
AB-CR-92-1784-11. Exterior view of port superstructure, amidships.

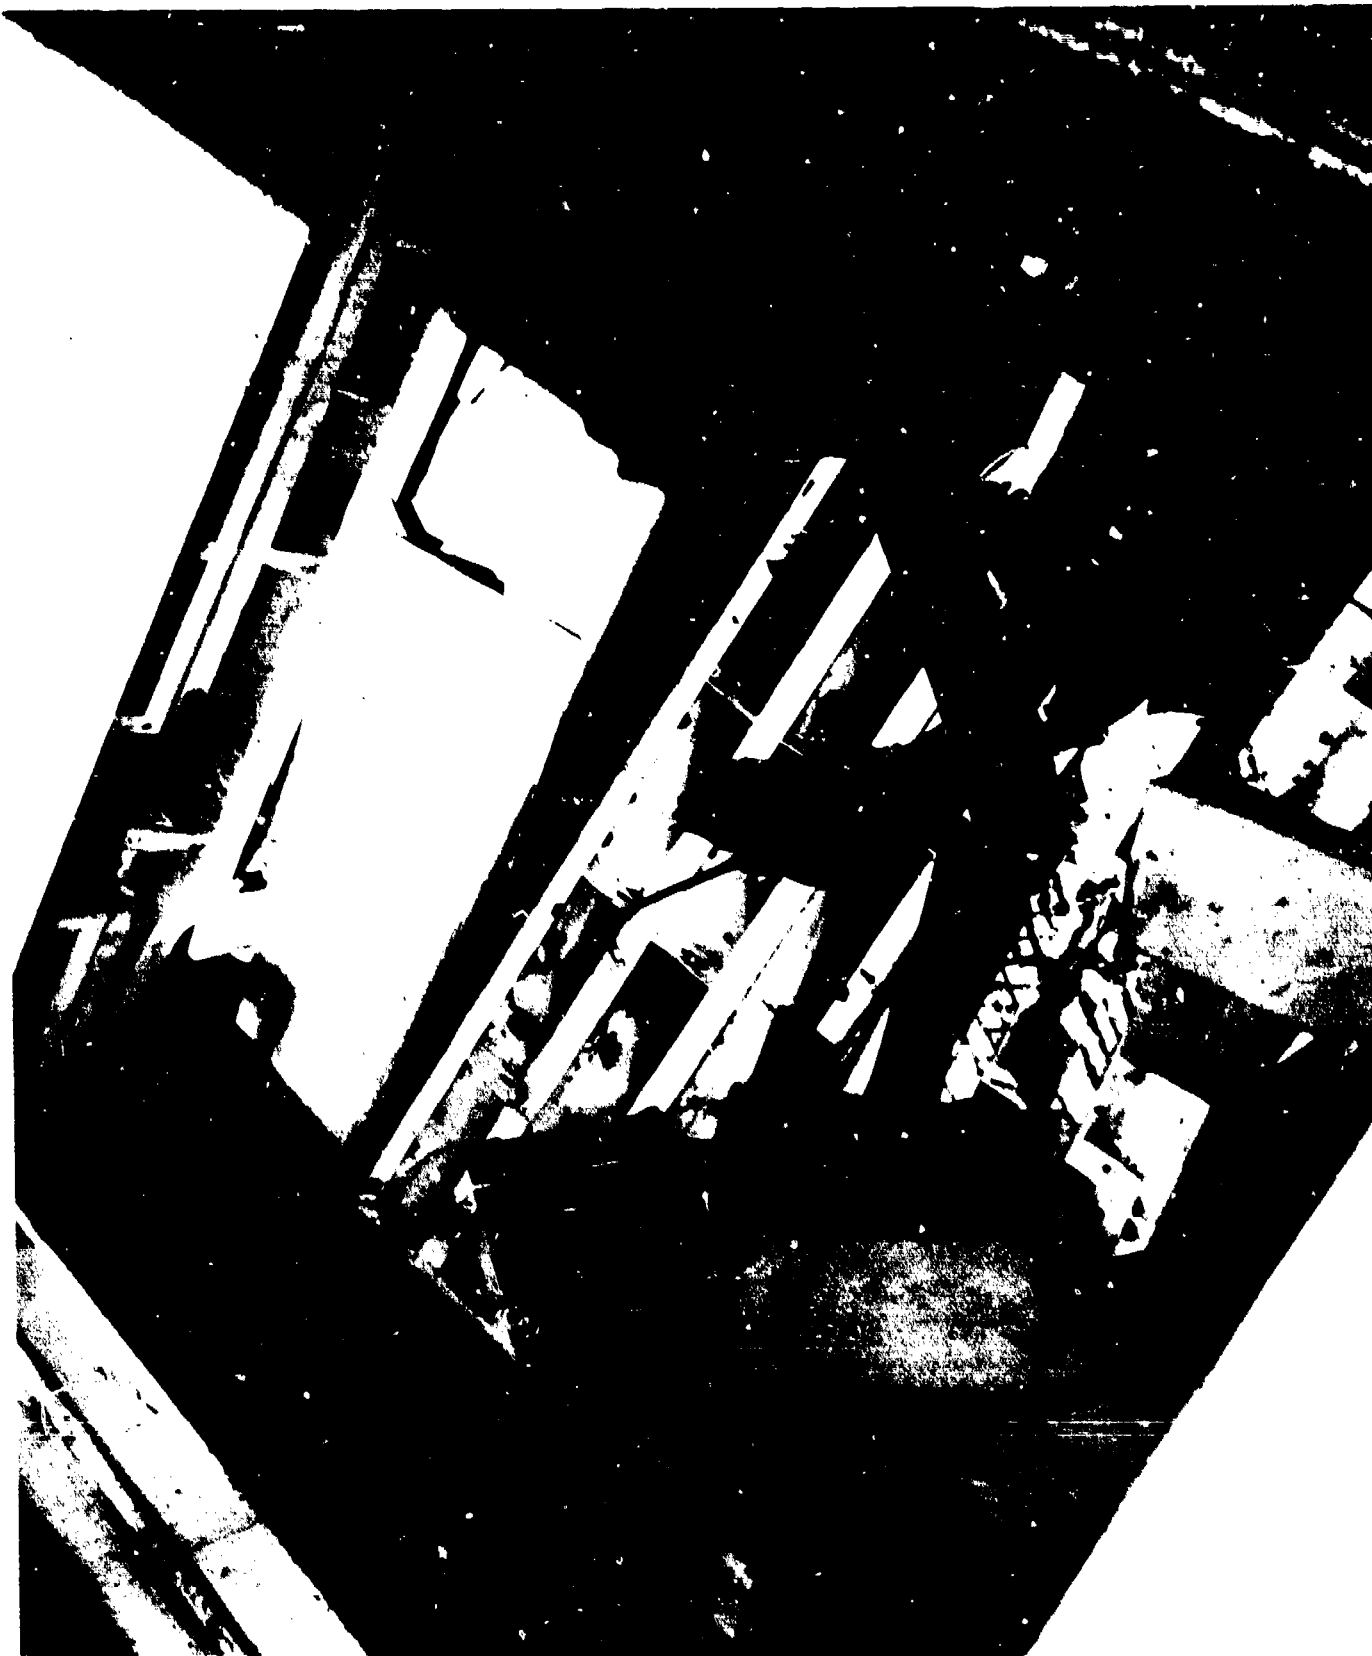
AB-CR-76-2218-8. Looking aft, down and to port into forward hold, A-5A, from main deck level. Note shifted ballast of concrete blocks.

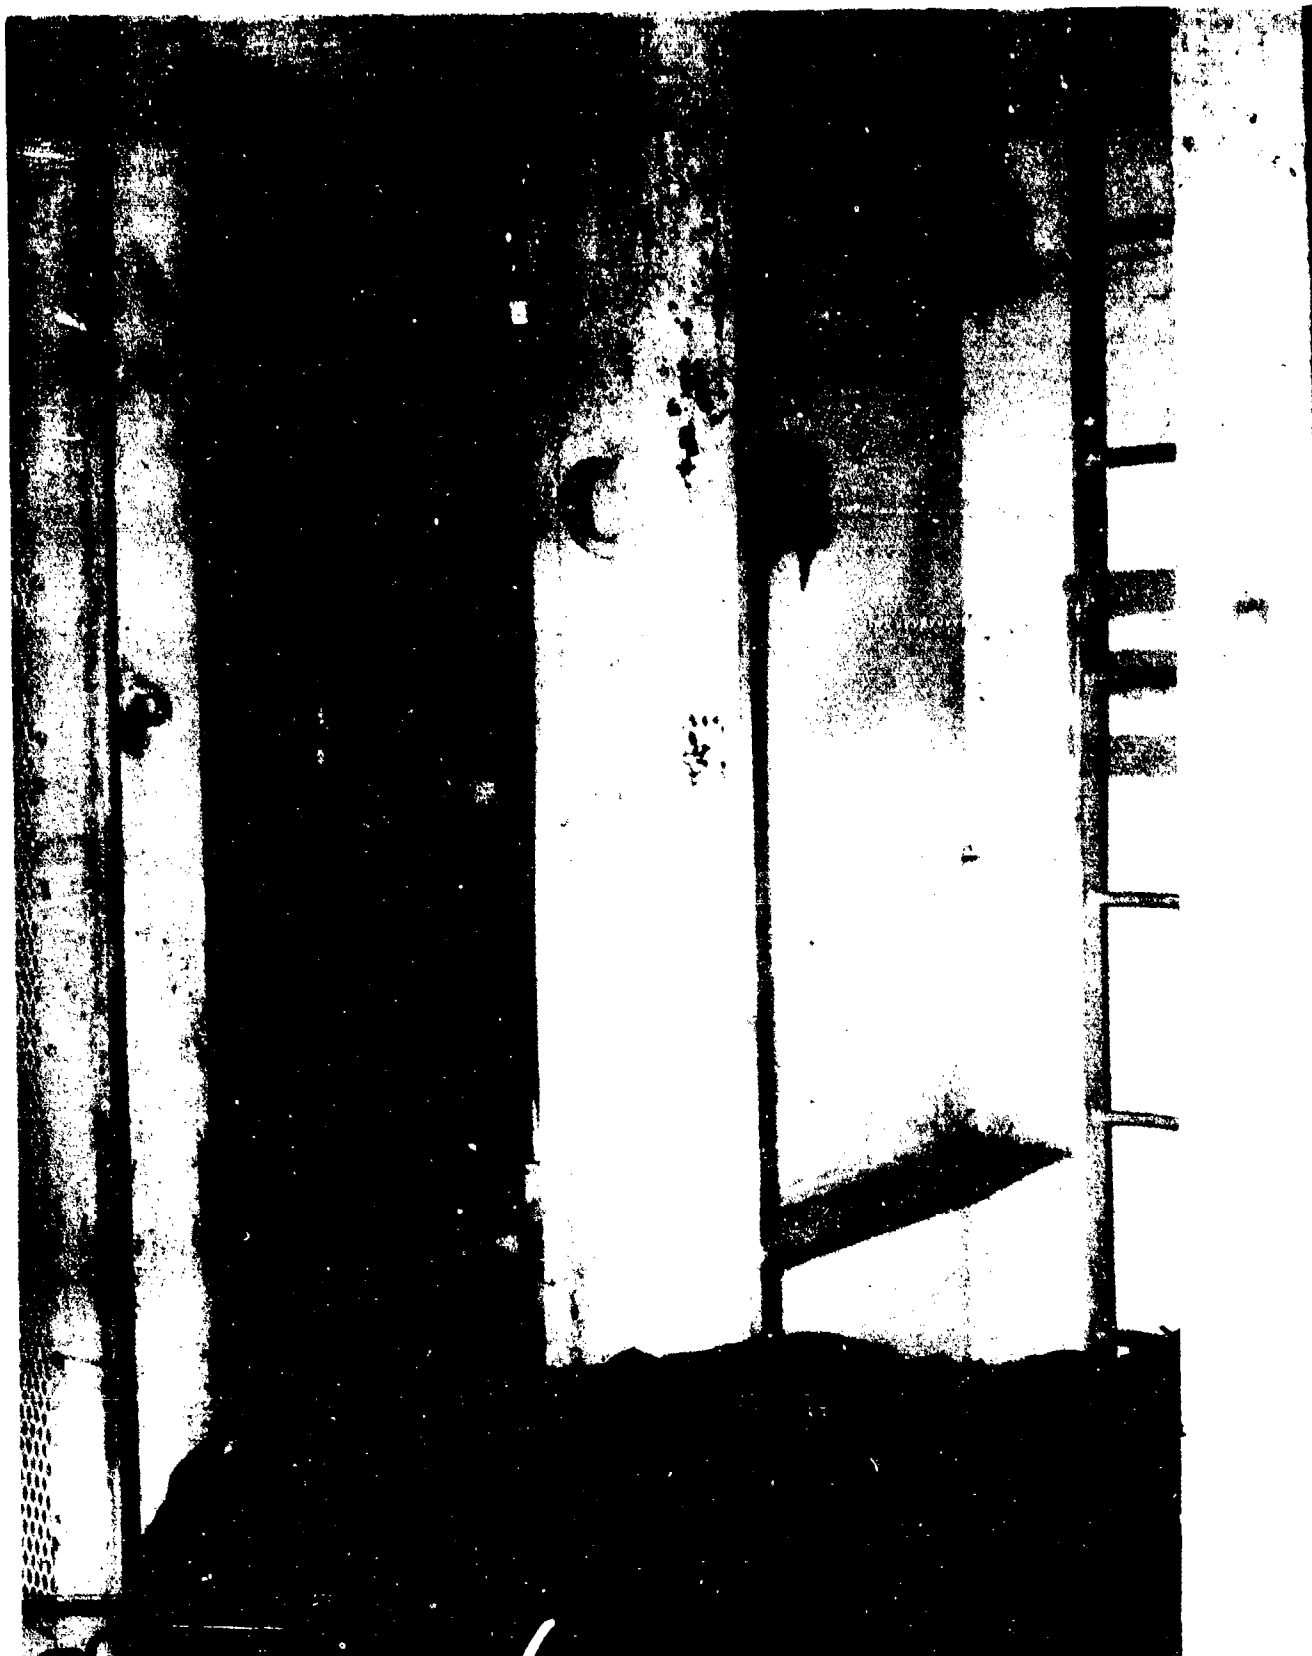
AB-CR-80-2195-6. Damage to web column in No. 1 hold in way of starboard edge of cargo hatch, just forward of bulkhead 56, in Co2 bottle stowage, looking aft and to starboard.

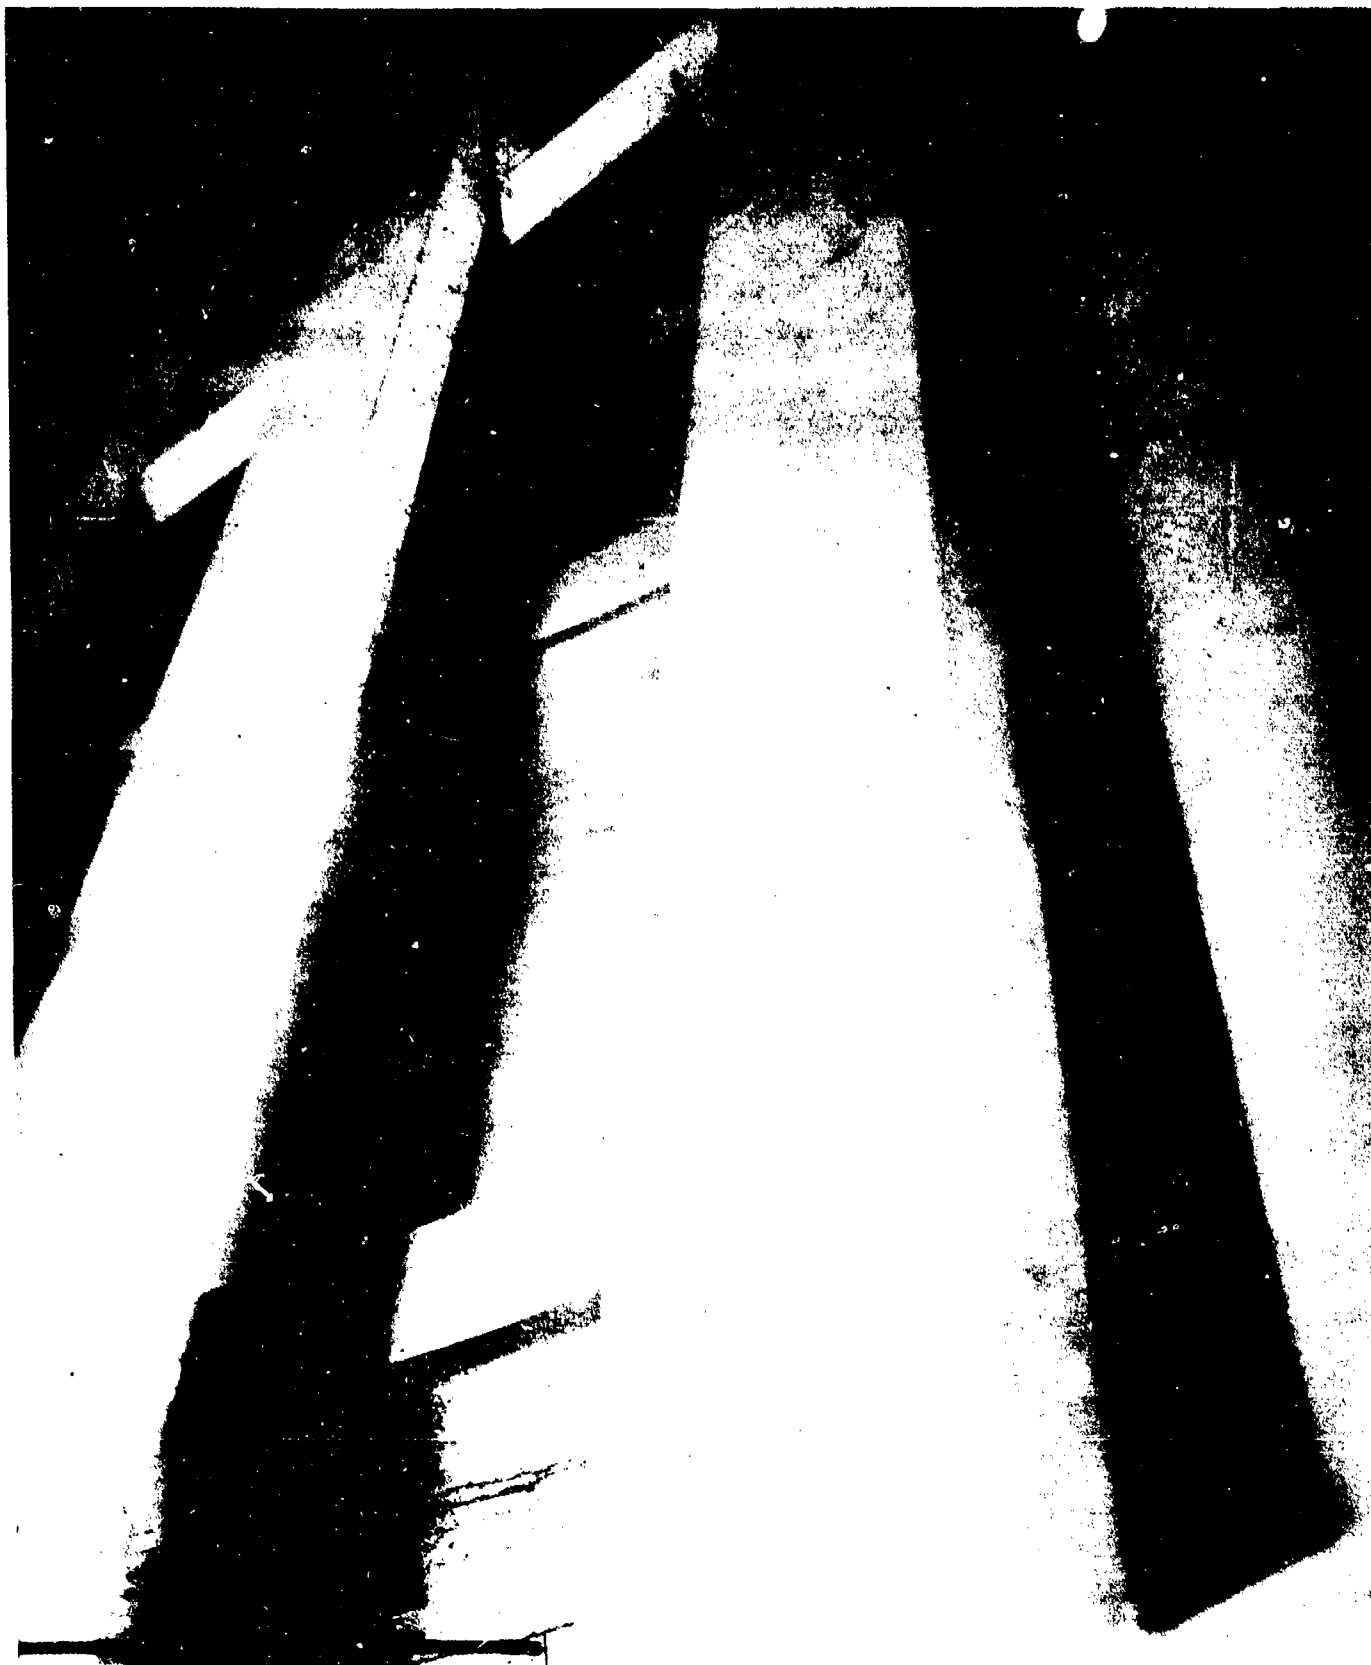
AB-CR-80-2195-4. No. 1 cargo hold, looking forward along port shell between frames 45 and 47 showing slight dishing of plating between frames.

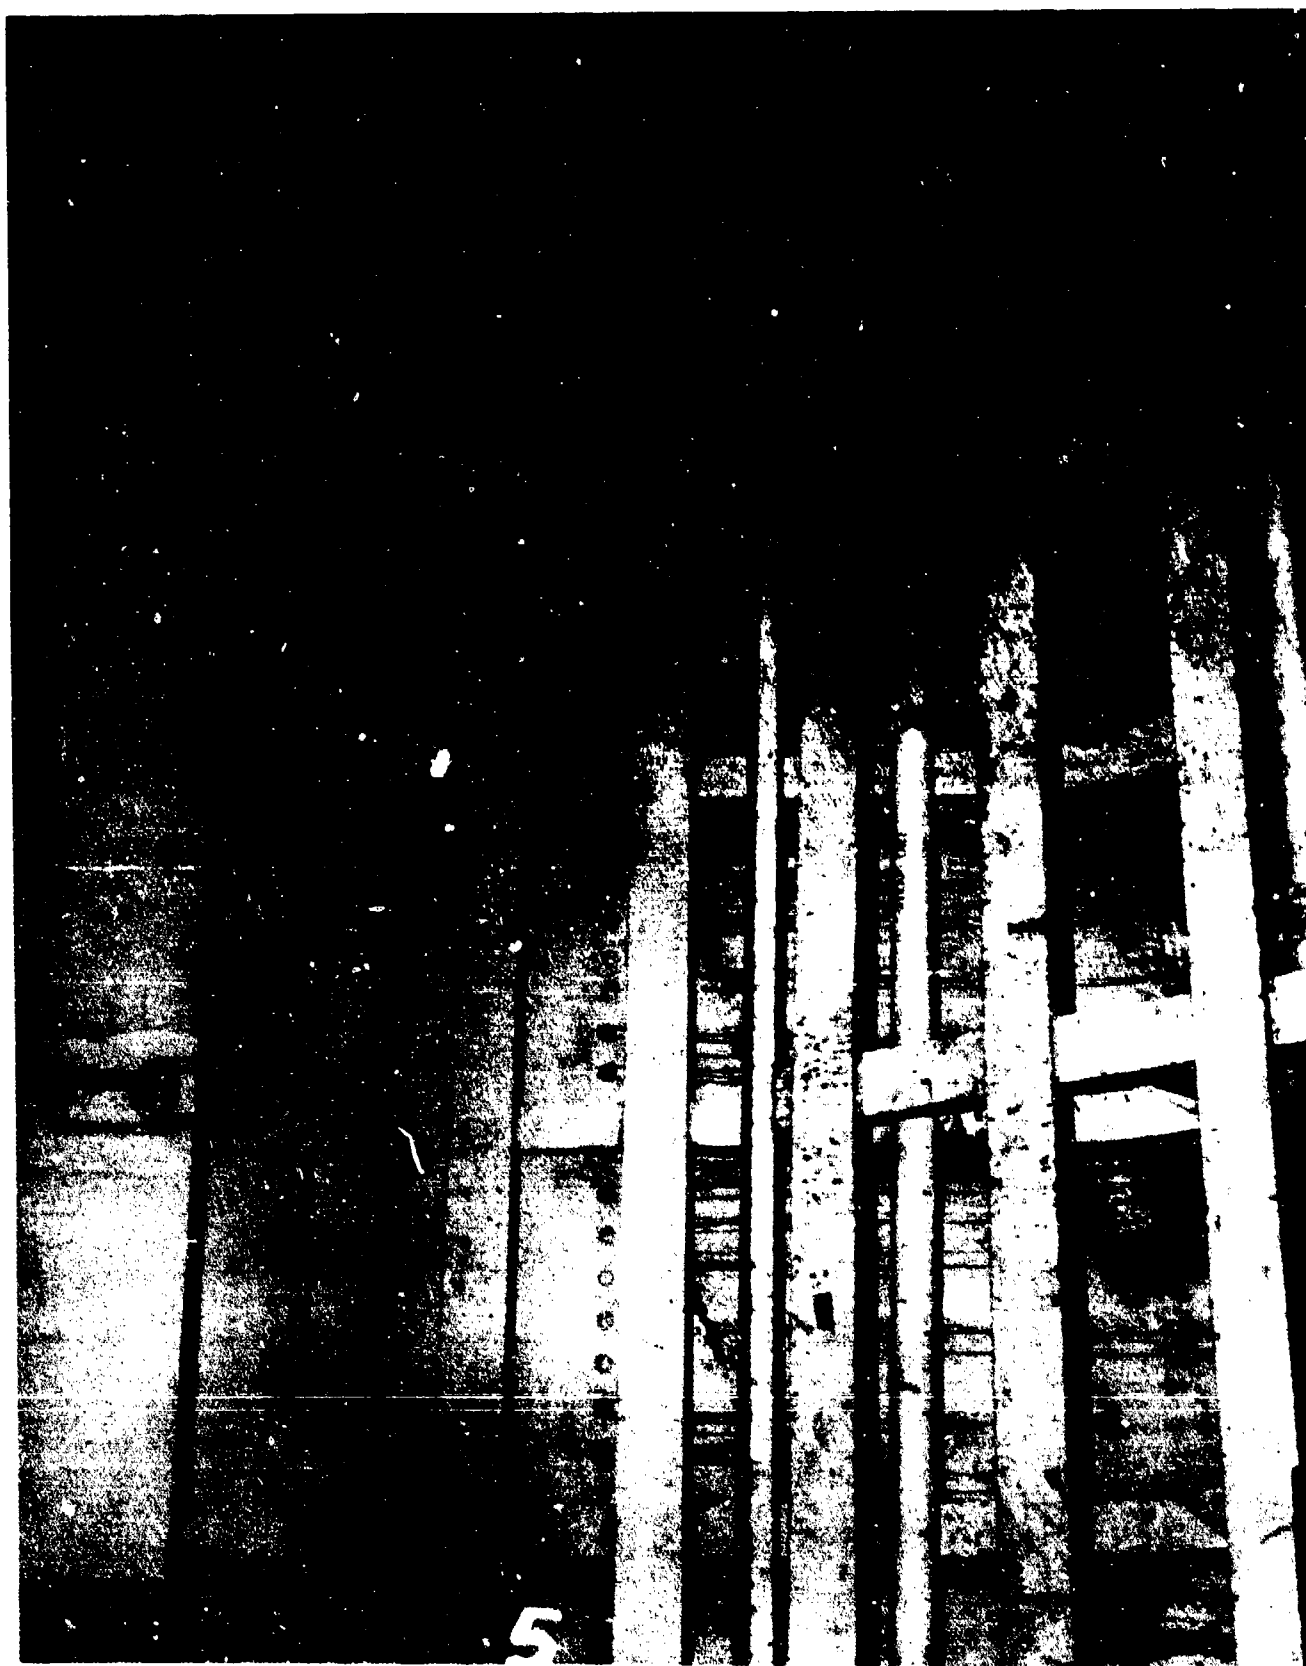
AB-CR-80-2195-5. No. 1 cargo hold, looking to port between frames 49 and 56 showing shell plating dished between frames.

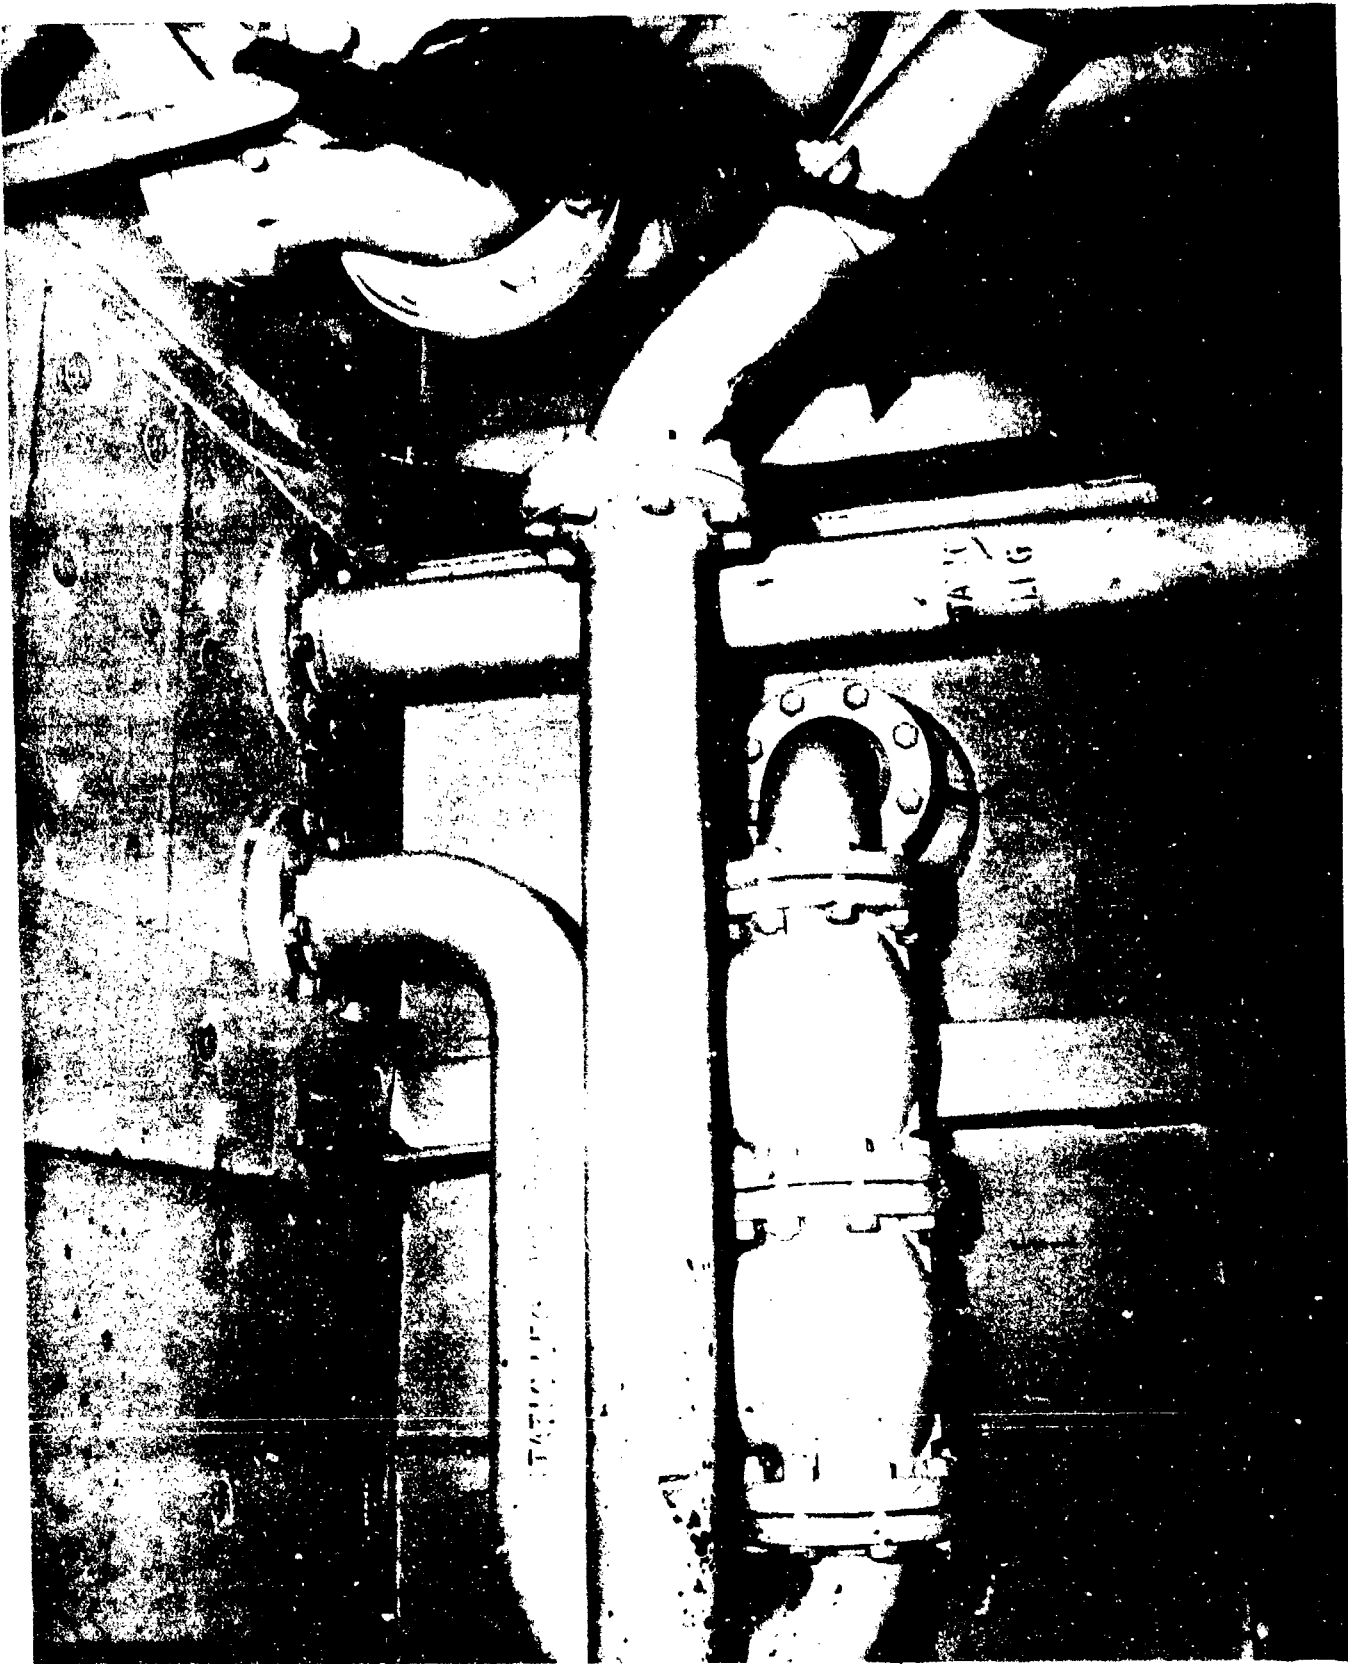
AB-CR-82-4227-11. Forward engine room, buckled brackets connecting side frames 78 and 79, starboard side, to main deck beams.

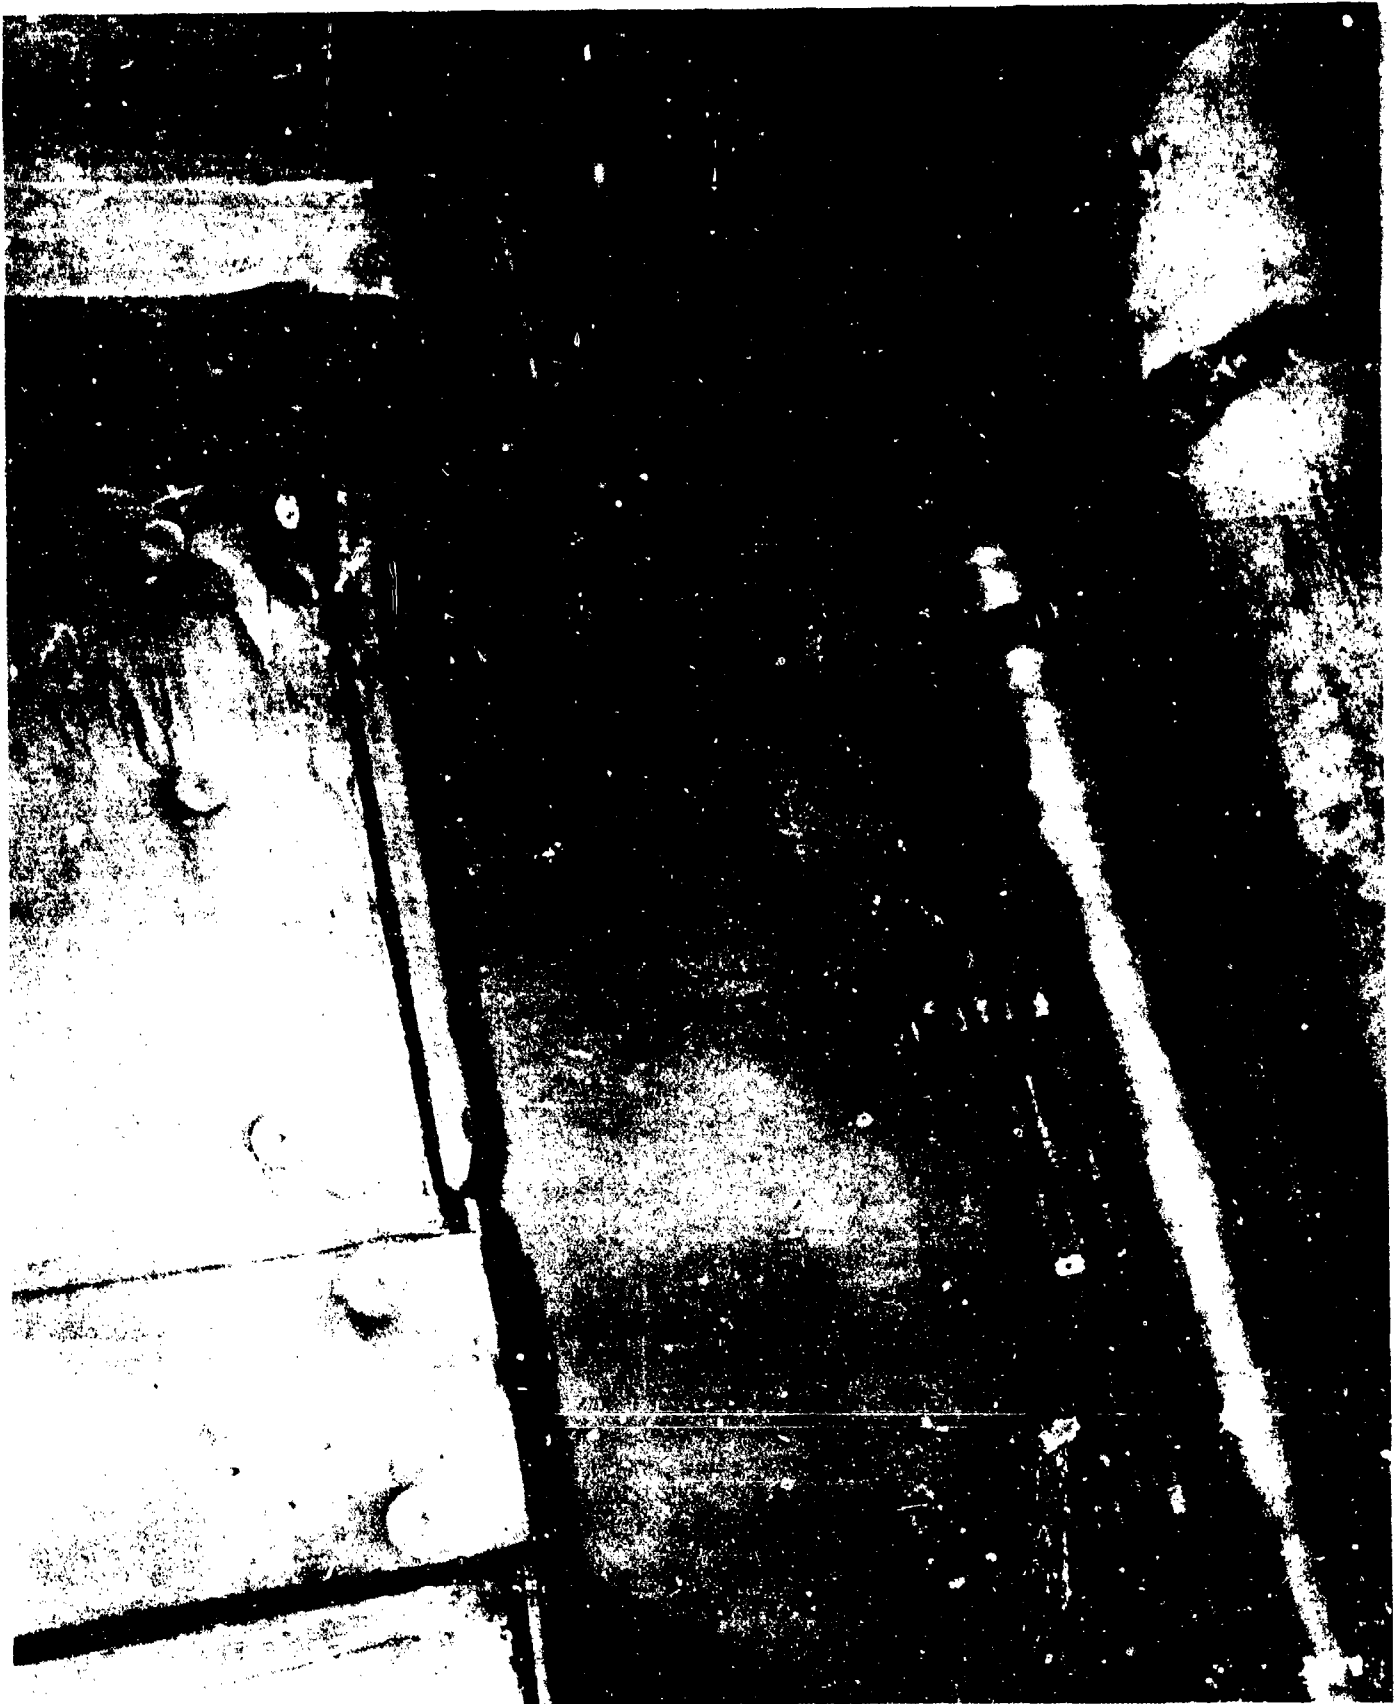
AB-CR-82-4228-8. After engine room, indications of stress in main deck transverse girder at frame 101 at connection to port longitudinal girder looking aft and to port.

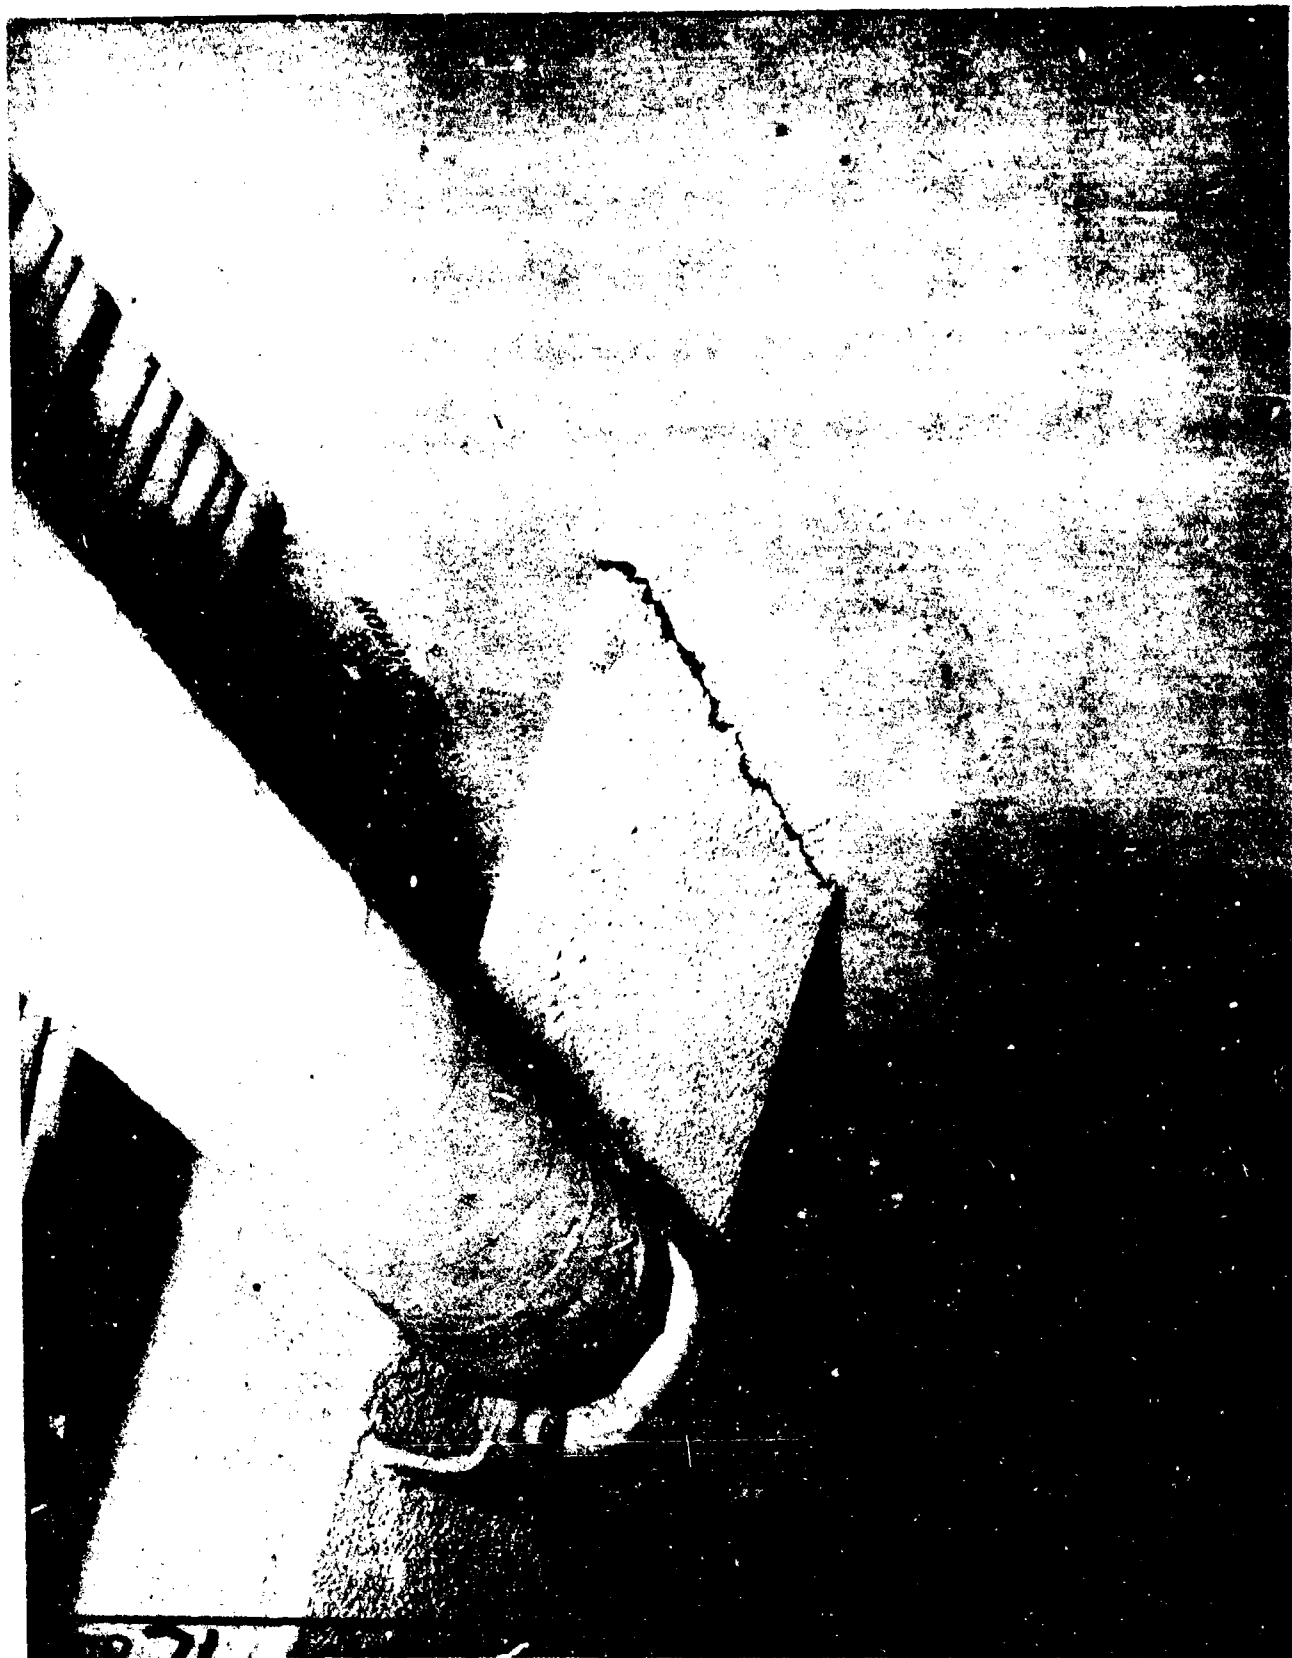
AB-CR-76-2083-5. Compartment C-101-L. Cracked weld at connection of starboard upper deck longitudinal girder to bulkhead 124, looking forward, up, and to port from main deck.
